STENC19003

**RE: MOLD ASSESSMENT
PEMBERTON HIGH SCHOOL – ROOMS 158 AND 274
148 ARNEY MOUNT ROAD
PEMBERTON, NEW JERSEY 08068**

MOLD ASSESSMENT

PEMBERTON HIGH SCHOOL – ROOMS 158 & 274
148 ARNEY MOUNT ROAD
PEMBERTON, NEW JERSEY

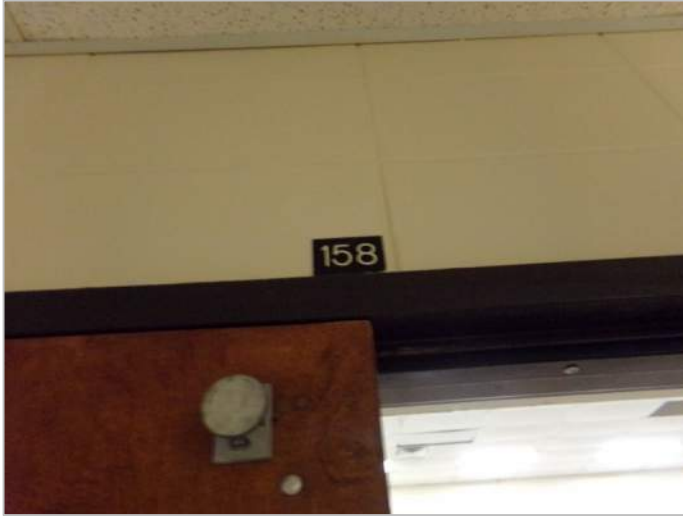
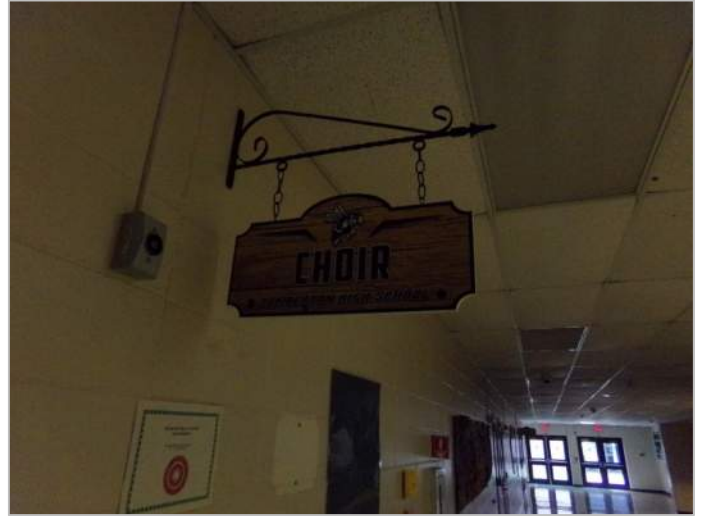
Photographs 1 and 2.
Entrance to Room 158 Choir Room

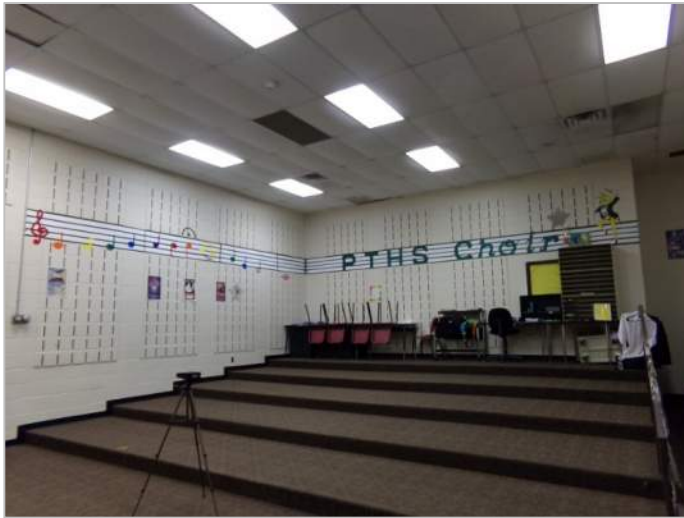
Photograph 3.
Overview of Room 158

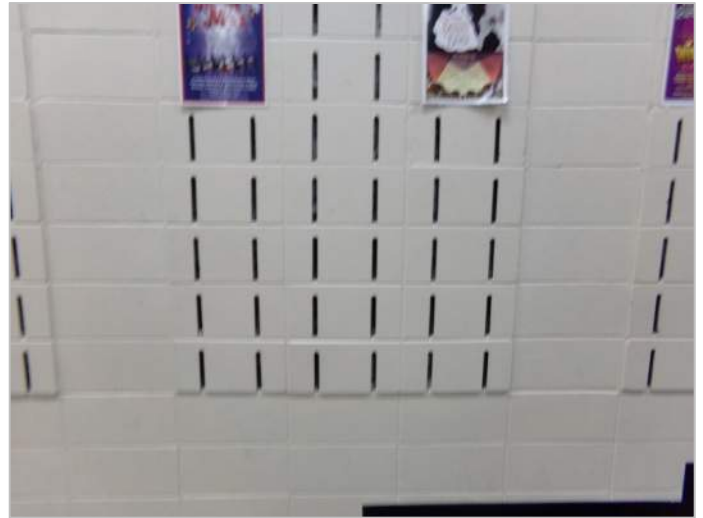
- The two HVAC returns and the vent to the hallway were covered with dust.
- The cinderblock walls are constructed with porous sound foam. The sound foam is behind the cinderblock walls. There are openings, 6 inches by ¾ inches, for the sound absorption. In areas inspected, the foam is deteriorated. The sound walls and room were constructed in 1991.

Photograph 4.
View of Openings in Sound Wall

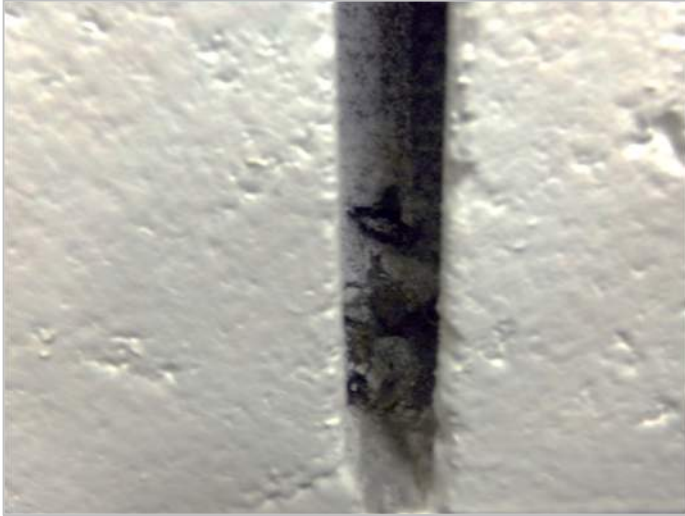
Photograph 5.

View of deteriorated sound foam behind concrete wall.

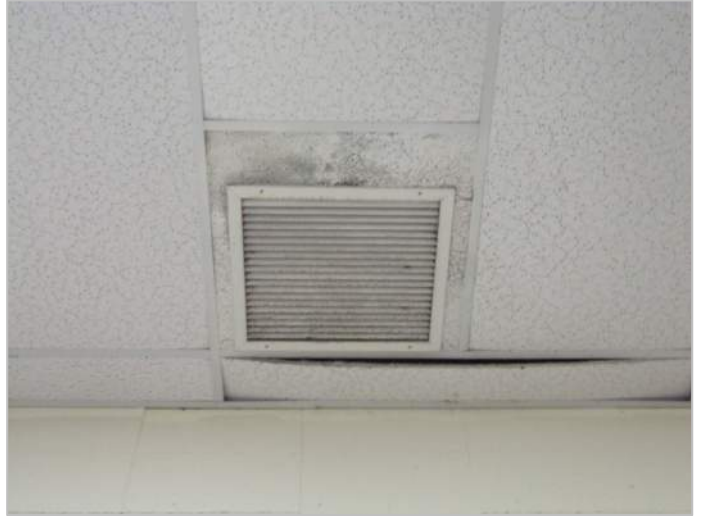
Photograph 6.

- No visible mold growth was observed on carpeting or walls.
- Seven ceiling tiles were observed with water stains of which one was observed with mold growth.

View of typical corroded return vent. Ceiling pictured is observed with mold growth.

1. Clean dirty HVAC returns and vent to hallway.
2. Replace water stained ceiling tiles.
3. Determine and correct the source of water staining (i.e., possible roof leak or condensate from AC unit).

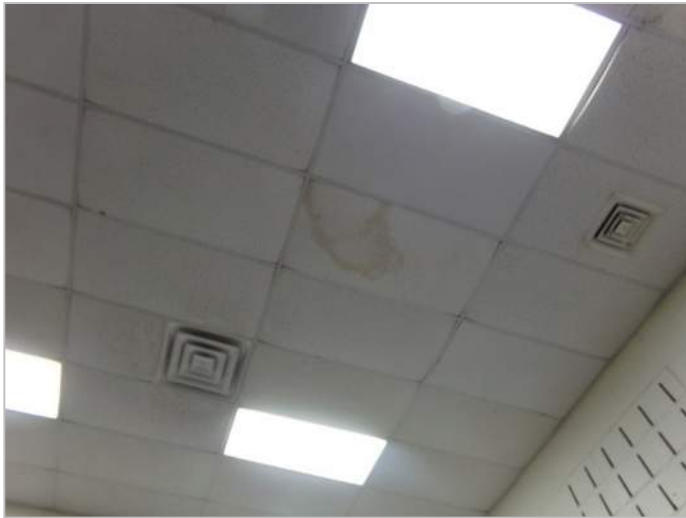
Photograph 7.

View of typical water stained ceiling tile.

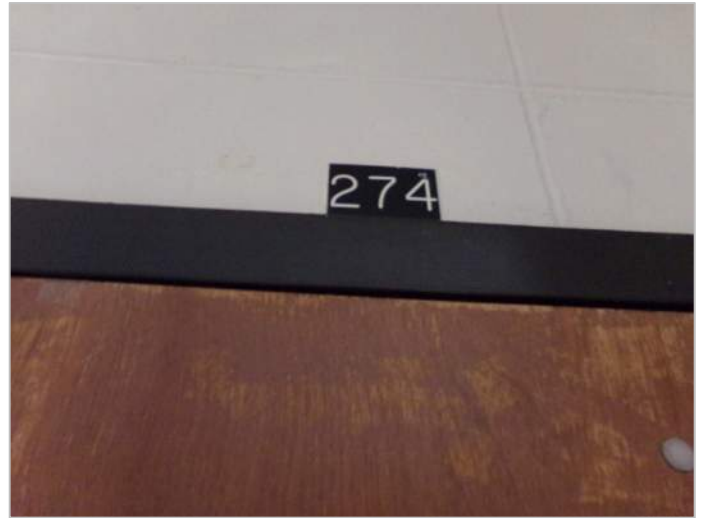
Photograph 8.

Entrance to Room 274

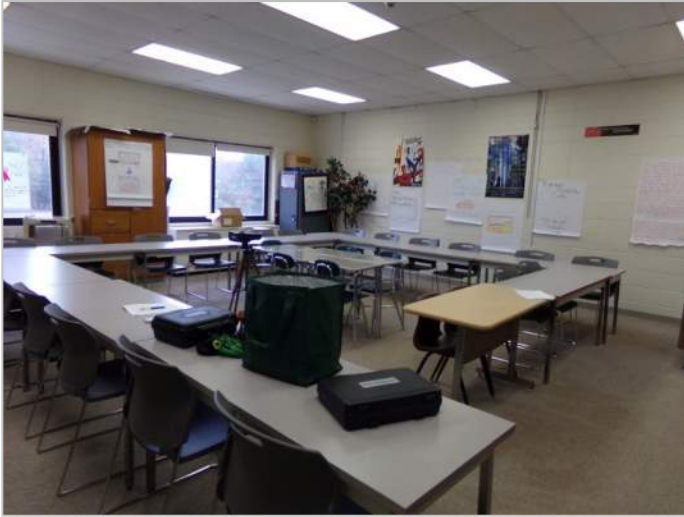
Photograph 9.
Overview of Room 274

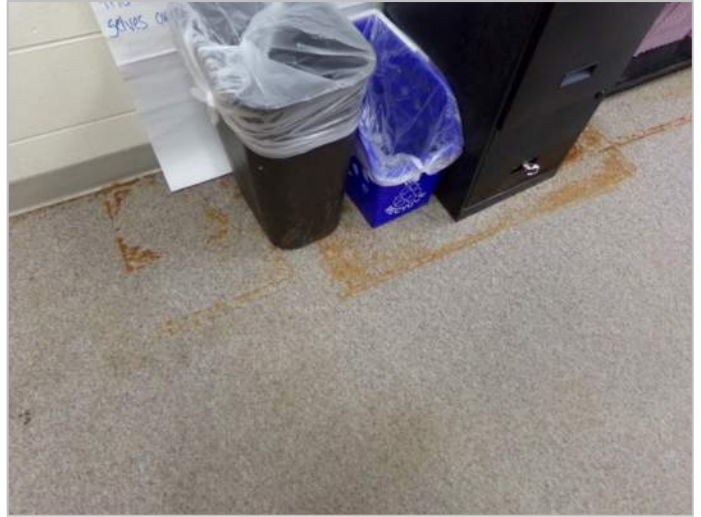
Photograph 10.
View of typical water staining on carpeting. Carpet was dry at the time of our assessment.

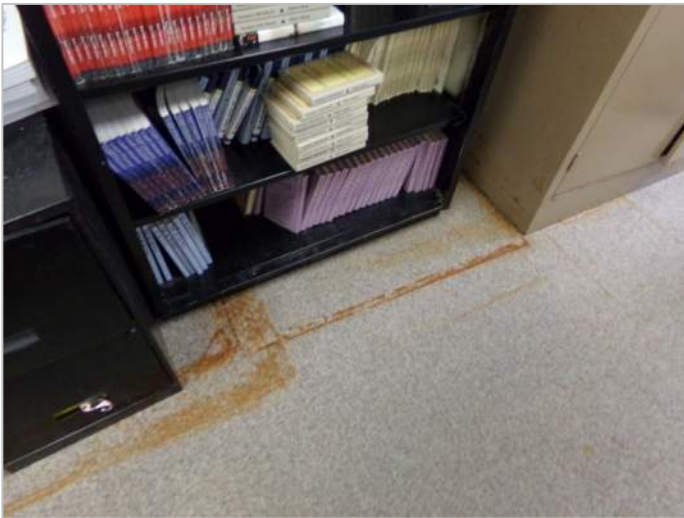
Photograph 11.
View of typical water staining on carpeting. Carpet was dry at the time of our assessment.
